# The Conservation of Subterranean Cultural Heritage

## The rock-cut tomb-chapels of Hery and Djehuty on the West Bank of Luxor: History, environment and conservation

**ABSTRACT:** The rock-cut tomb-chapels of Djehuty and Hery (TT 11–12) are located on the West Bank of Luxor, Egypt, at the northern end of the necropolis of ancient Thebes. They date to the early 18th Dynasty, in the first half of the 15th century B.C. Both were later on reused for different purposes and their structures were altered. The decoration of their inner walls has suffered from running water, wind blowing through, fires lit inside and 19th/early 20th century robbers cutting out fragments to be sold to tourists. Moreover, the nature of the rock (limestone) and the environmental conditions (humidity) also affects the monuments' state of preservation. A Spanish archaeological mission has been working in the tomb-chapels since 2002, conducting consecutive annual campaigns in the months of January and February. Their work entails excavation, documentation, conservation and restoration, aiming to open the monuments to the public in the near future.

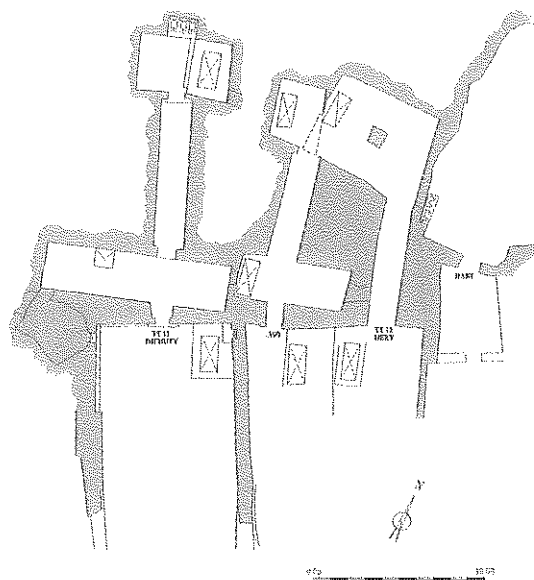
Figure 2. Plane of the inner part of the tomb-chapels.

The funerary monuments penetrate into the hillside almost following a parallel orientation, close to South–North; although, adopting the ideological and religious reasoning of the ancient Egyptians they were oriented East–West, so that the deceased would join the solar disk at sunset. They were originally independent structures, but ended up interconnected when the separating walls were later on intentionally broken. That is one of the reasons why the concession granted to the Spanish mission included more than one monument (Fig. 2).

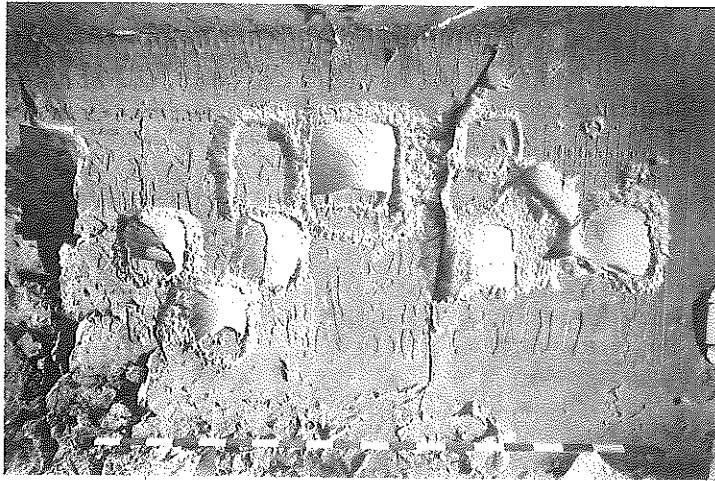
Figure 4. Left wall of the corridor of the tomb-chapel of Hery, after being plundered. (See colour plate section, page 305).

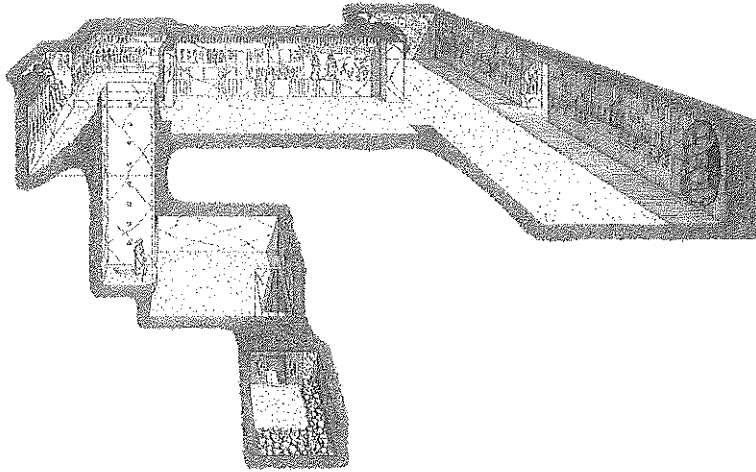
Figure 6. Section of the tomb-chapel of Djehuty (TT 11) (drawing by C. Cabrera).

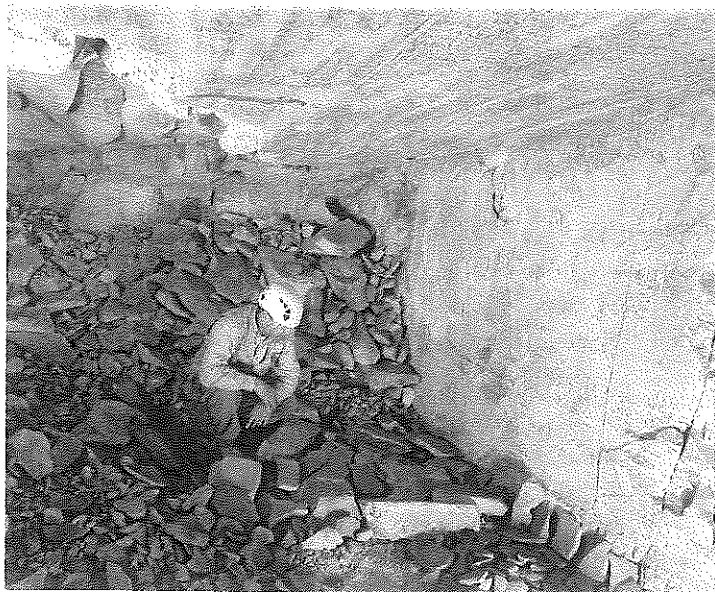
Figure 7. Burial chamber of Djehuty as found by the Spanish mission. (See colour plate section, page 305).

The ancient Egyptians were very keen in indicating through steps the different spaces of a building, and thus, to go inside both chambers one has to descend a 0.45 m rock-cut step. The burial chamber was designed roughly quadrangular, 2.70 × 2.60 × 1.55 m tall, and the entrance was centered at the east/north wall. The four walls and the ceiling got their surface smoothen and then covered with a layer of mortar and a layer of stucco. The mortar contains no straw, and it is made of 50% gypsum, 30% calcite, and 15% quartz (sand), while the stucco is almost pure gypsum. The four walls and the ceiling were then fully written with passages from the Book of the Dead, using a thin brush and black ink, leaving the red ink to highlight the titles of each of the spells and to emphasize the dramatization of certain passages. Contrary to what was customary among painters, the scribes used very little or no binding at all to fix the ink. The text of some of the spells was accompanied by a vignette, whenever it seemed relevant to convey the physical appearance of the animal, plant, deity or place mentioned (Fig. 7).

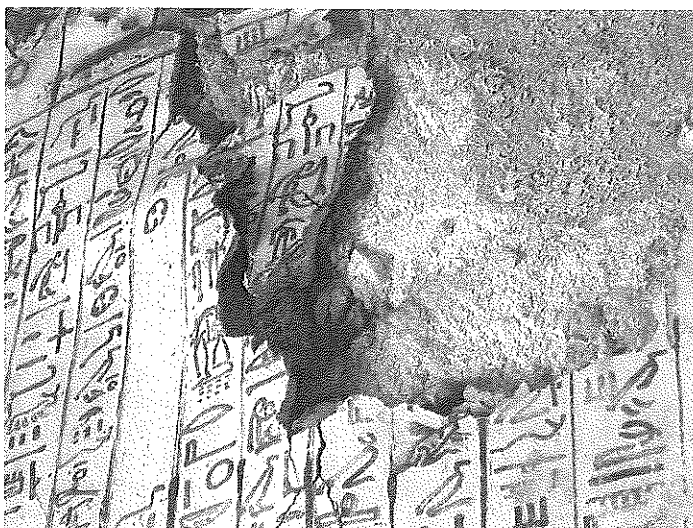
Figure 8. Detachment of stucco from the parent rock in the tomb-chapel of Djehuty. (See colour plate section, page 305).

The successive processes of wetting/drying along episodes of rise and fall of the Nile river, and the opening of the burial chamber at the very end of the 19th century, caused the reactivation of the limestone salts and their migration to the surface of the walls, precipitating and detaching the stucco plates from the rock (Fig. 8). Gypsum and halite salts are easily observed on the surface of the lower level of the walls, where the variation of rock moisture content is more intense and the layer of stucco thinner. While on the one hand short-term changes in humidity have favored the detachment of large areas of stucco from the walls, on the other hand high humidity and relatively stable thermo-hygrometric conditions have helped to avoid dehydration of gypsum plasters and subsequent cracking. The common desiccation from gypsum to anhydrite in the near dry environments involves volume reduction and deterioration. The critical air relative humidity for gypsum stability in temperature range of  $25^{\circ}\text{--}30^{\circ}\text{C}$  is above 75%.

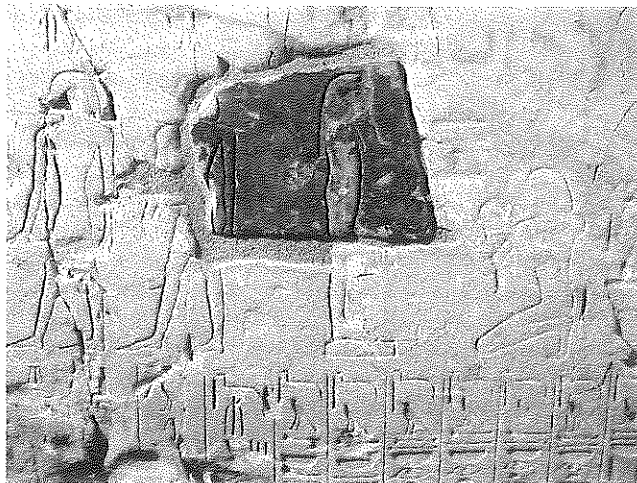
Figure 10. Detached fragment placed back in its original position, in the tomb-chapel of Djehuty. (See colour plate section, page 306).

Removing the mud crust attached to certain areas of the walls has not been an easy task, because it was strongly fixed to the slats that crystallized on the surface, and if the salts are removed there is a risk that the relief would be damaged. We have been removing the mud mechanically with a scalpel, after moistening it first with cotton and alcohol. It is certainly a very slow procedure. We have also used in certain areas a vibrating cutter with ultrasound, operated in connection with an air compressor, achieving remarkable results, both in the cleaning speed and in the precision with which it can be conducted. Thanks to this technique, numerous demotic graffiti that could not be seen underneath the mud crust are now easily legible for the epigraphist expert in this particular script (Fig. 11), Tina di Cerbo and Richard

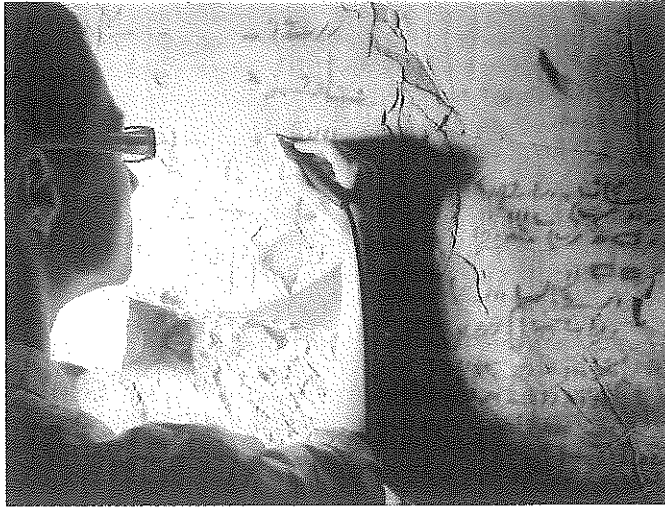
Figure 11. Removing the mud crust by using a vibrating cutter, turning visible the graffiti in the tomb-chapel of Djehuty. (See colour plate section, page 306).

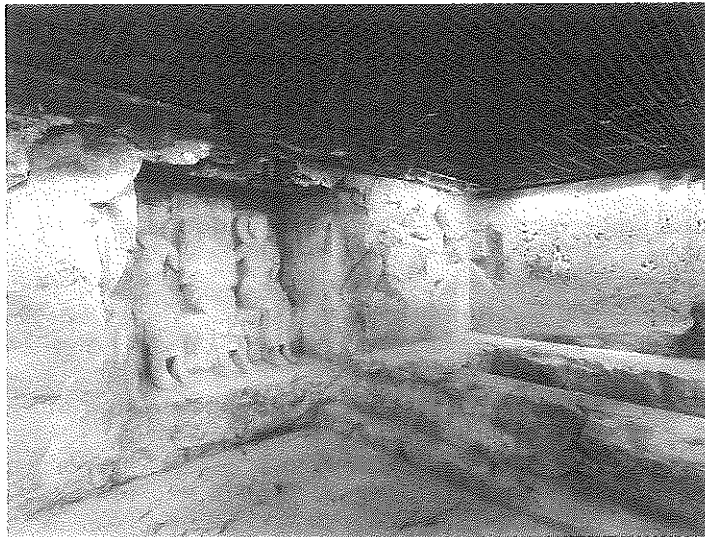
Figure 12. Djehuty's inner most room with an iron ceiling and LED lights installed. (See colour plate section, page 306).

Following the same basic idea that guided our work in the burial chamber, i.e. that it is impossible to predict how the ceiling would behave, and thus which area or block would fall off first, it was considered more realistic, feasible and esthetically more attractive to minimize the effects resulting from the detachment of a block or part of the ceiling. For that purpose a 'false' iron ceiling was installed at the innermost room of the tomb-chapel of Djehuty. The original ceiling was here completely broken, with two big holes on the sidewalls that communicate with two tomb-chapels located half a meter higher up in the hill-slope. Taking advantage of this situation, two iron beams were set across the room, resting on the sidewalls. From these two strong beams we welded and hung an iron bar structure, like "ribs", cut to size,

and covering the entire area of the room. And hanging from the bars, we soldered a mesh/grid of iron. The latter two structures are divided into four sections, which can descend and ascend again independently by a pulley system. This design will permit, in the unlikely event that a rock might fall from the ceiling, to remove it easily by lowering the section where it had fallen, and reset the roof by ascending the section again, now without the block. The system is designed to prevent the fallen stones from causing any personal or material damage, and then facilitate its removal (Fig. 12).

Taking advantage of the installation of the false iron ceiling, we fixed along the entire perimeter tubes of small 2700°K LED bulbs to illuminate the wall reliefs from top to bottom; the lights are not visible, nor do they bother on the floor, which is a novelty in the lighting of pharaonic tombs. The effect is quite attractive, as the reliefs can now be appreciated as if they were on display in a museum. During the 2014 season, a similar iron ceiling and LED tubes were installed on the ceiling of the central corridor. The entrance to the funerary shaft that leads to the painted burial chamber of Djehuty was closed with an iron structure, which has a flap at one end to permit going up and down using the metal ladder installed along the shaft.
